# PROJECT MONITORING COMMITTEE ON-SITE INSPECTION

February 24, 2026

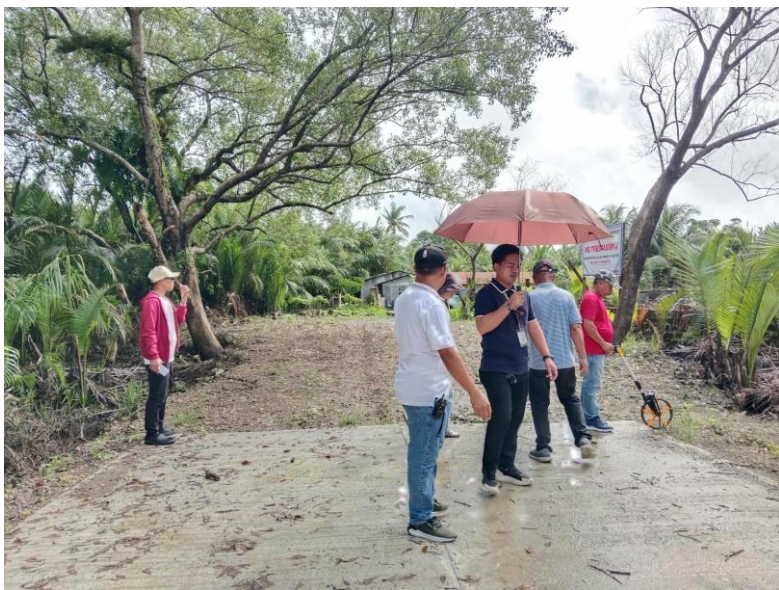
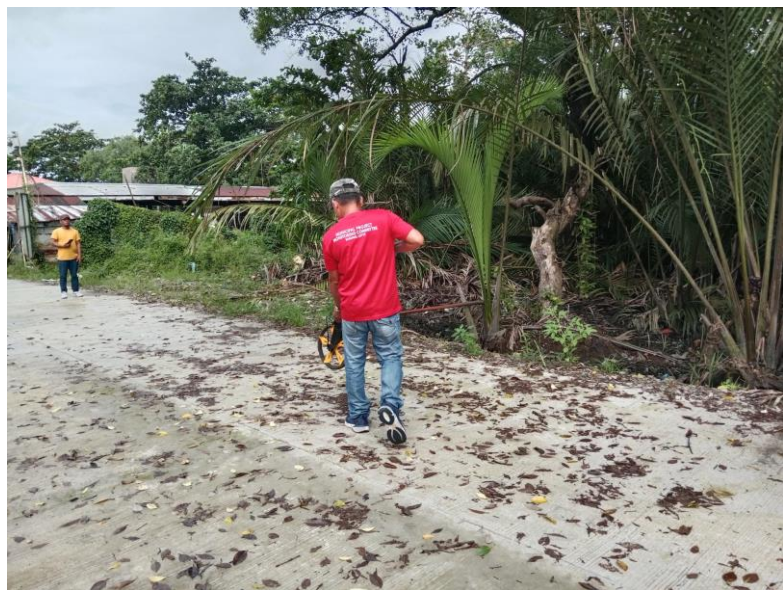
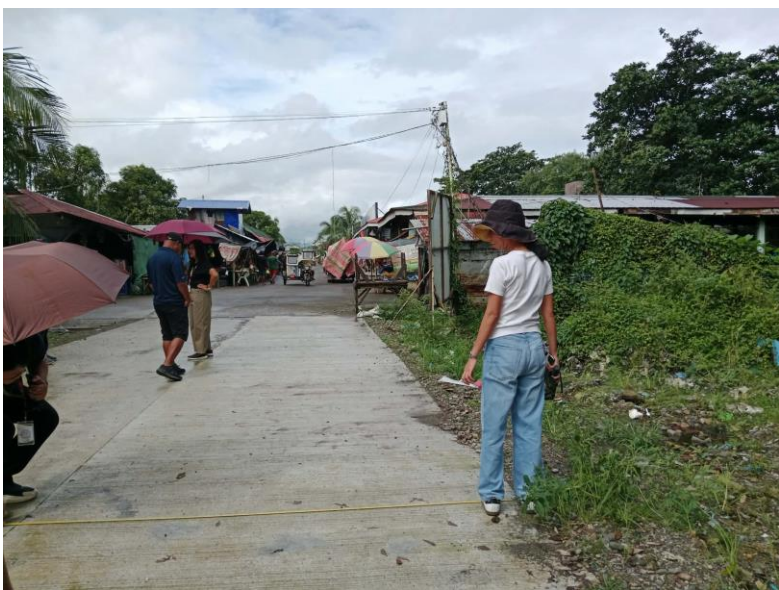
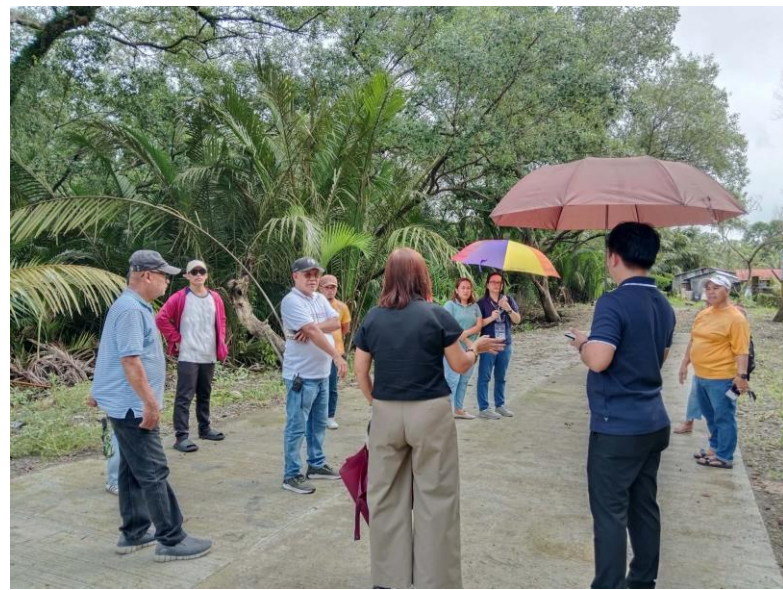
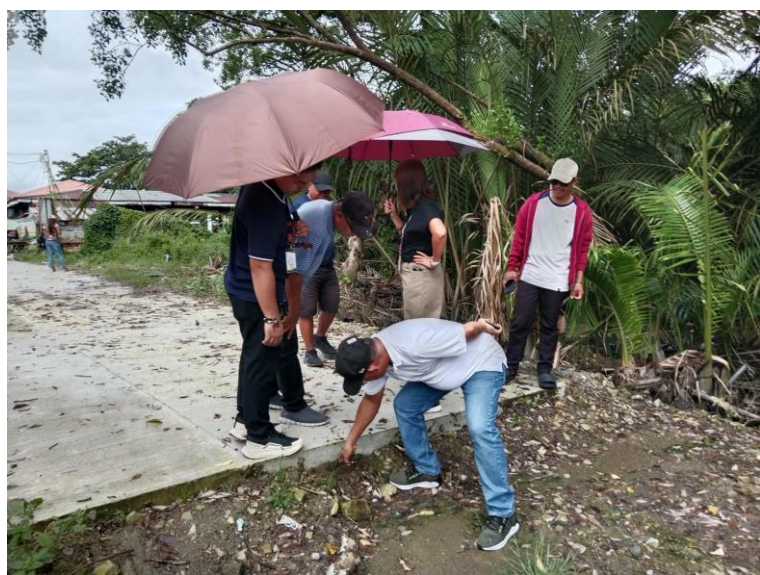
During the inspection of the Construction of concrete road along Simeona Apostol St. to San Francisco St. Pob. Dist. III, Hon. Danilo B. Bugal, *Punong Barangay of Brgy. Balire, Barugo, Leyte*, observed that the existing project has insufficient contraction joints. In response, Engr. Ranie N. Cebrano, *the Municipal Engineer*, explained that a contraction joint is a cut between two connected concrete road sections. He emphasized that it is important because it allows internal stress or pressure within the concrete pavement to be released, thereby preventing cracks. Mr. Renato Claros, *Representative of KABALIKAT CIVICOM LEYTE, Inc.*, inquired whether the road shouldering of the project is adequate. Engr. Ranie N. Cebrano, *the Municipal Engineer*, clarified that the road shouldering of the project was properly constructed using gravel materials. Furthermore, Hon. Jose B. Peñaranda, *Punong Barangay of Pob. Dist. VI, Barugo, Leyte*, asked about the minimum required width of the road shoulder. Engr. Ranie N. Cebrano, *the Municipal Engineer*, responded that the minimum width is one (1) meter. However, Hon. Jose B. Peñaranda, *Punong Barangay of Pob. Dist. VI, Barugo, Leyte* observed that the existing road shoulder appears to be insufficient in width. Engr. Ranie N. Cebrano, *the Municipal Engineer*, acknowledged the observations and stated that he will inform the contractor regarding the concerns raised by the committee members.
