# MUNICIPAL PROJECT MONITORING COMMITTEE

PROJECT MONITORING COMMITTEE ON-SITE INSPECTION RE:  
CONCRETING OF 70ln.m. LOCAL ACCESS ROAD ALONG SITIO PAMONGSORAN  
BRGY. BUKID BARUGO, LEYTE  
September 01, 2026

PROJECT MONITORING COMMITTEE ON-SITE INSPECTION RE:  
CONCRETING OF 170ln.m. ALONG SITIO MARIKOT 1 TO SITIO MARIKOT 2,  
BRGY. BUKID BARUGO, LEYTE  
September 01, 2026

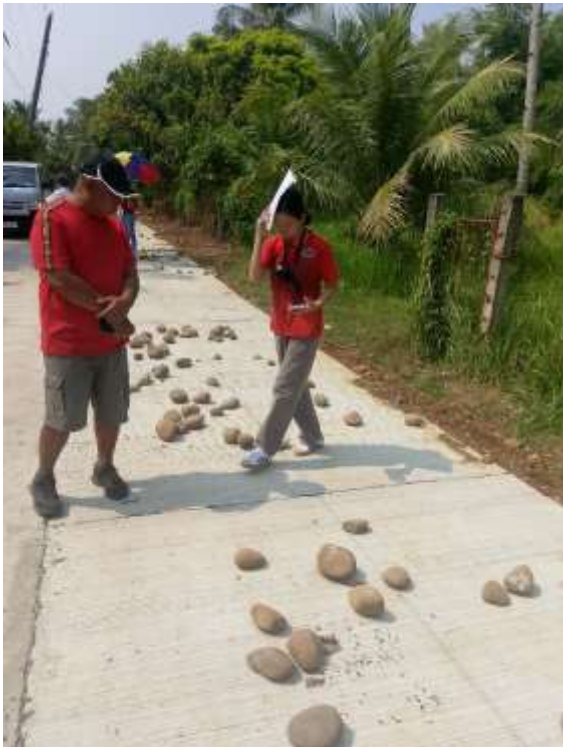
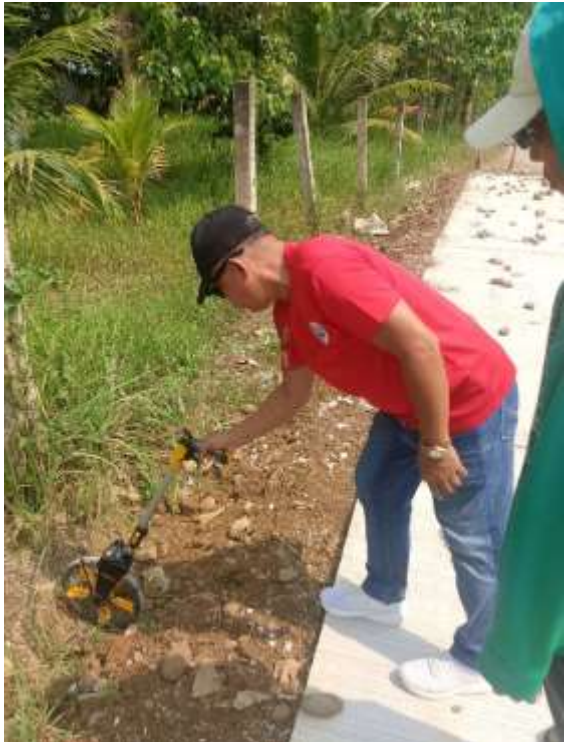
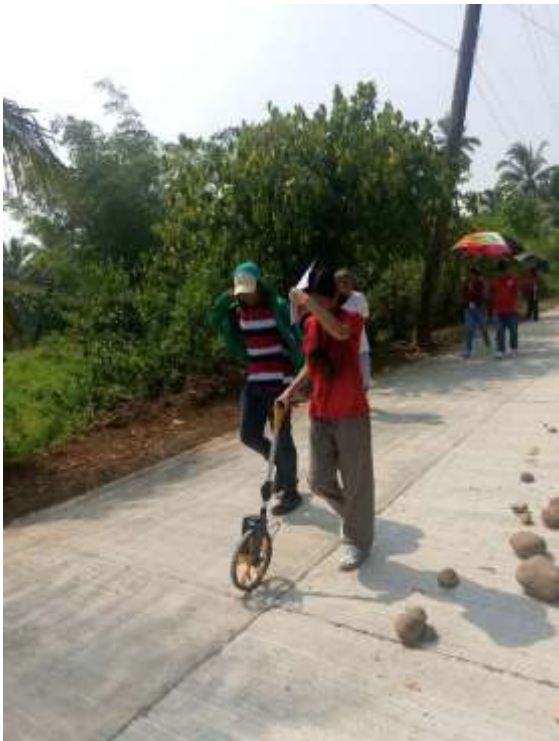
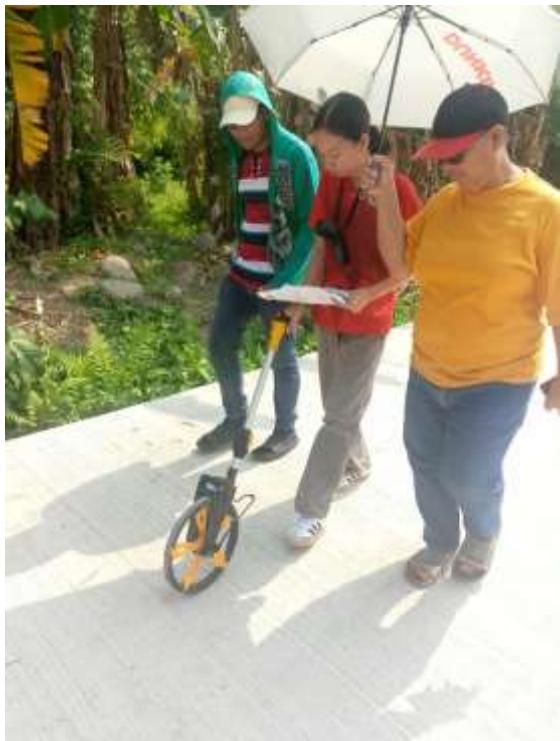
During the inspection of the concreting of the 70 linear meters (ln.m.) Local Access Road along Sitio Pamongsoran, Barangay Bukid, Barugo, Leyte, funded under the AIP CY 2026 – 20% Local Development Fund, the Committee observed the absence of road shoulders, which may pose a safety concern to passengers, commuters, and other road users traversing the project area.

The committee also conducted an actual measurement of the completed road project to verify its dimensions against the approved plan. The measurement confirmed that the actual road length was consistent with the specified length in the plan; however, the actual road width exceeded the prescribed measurement by 0.10 meter.

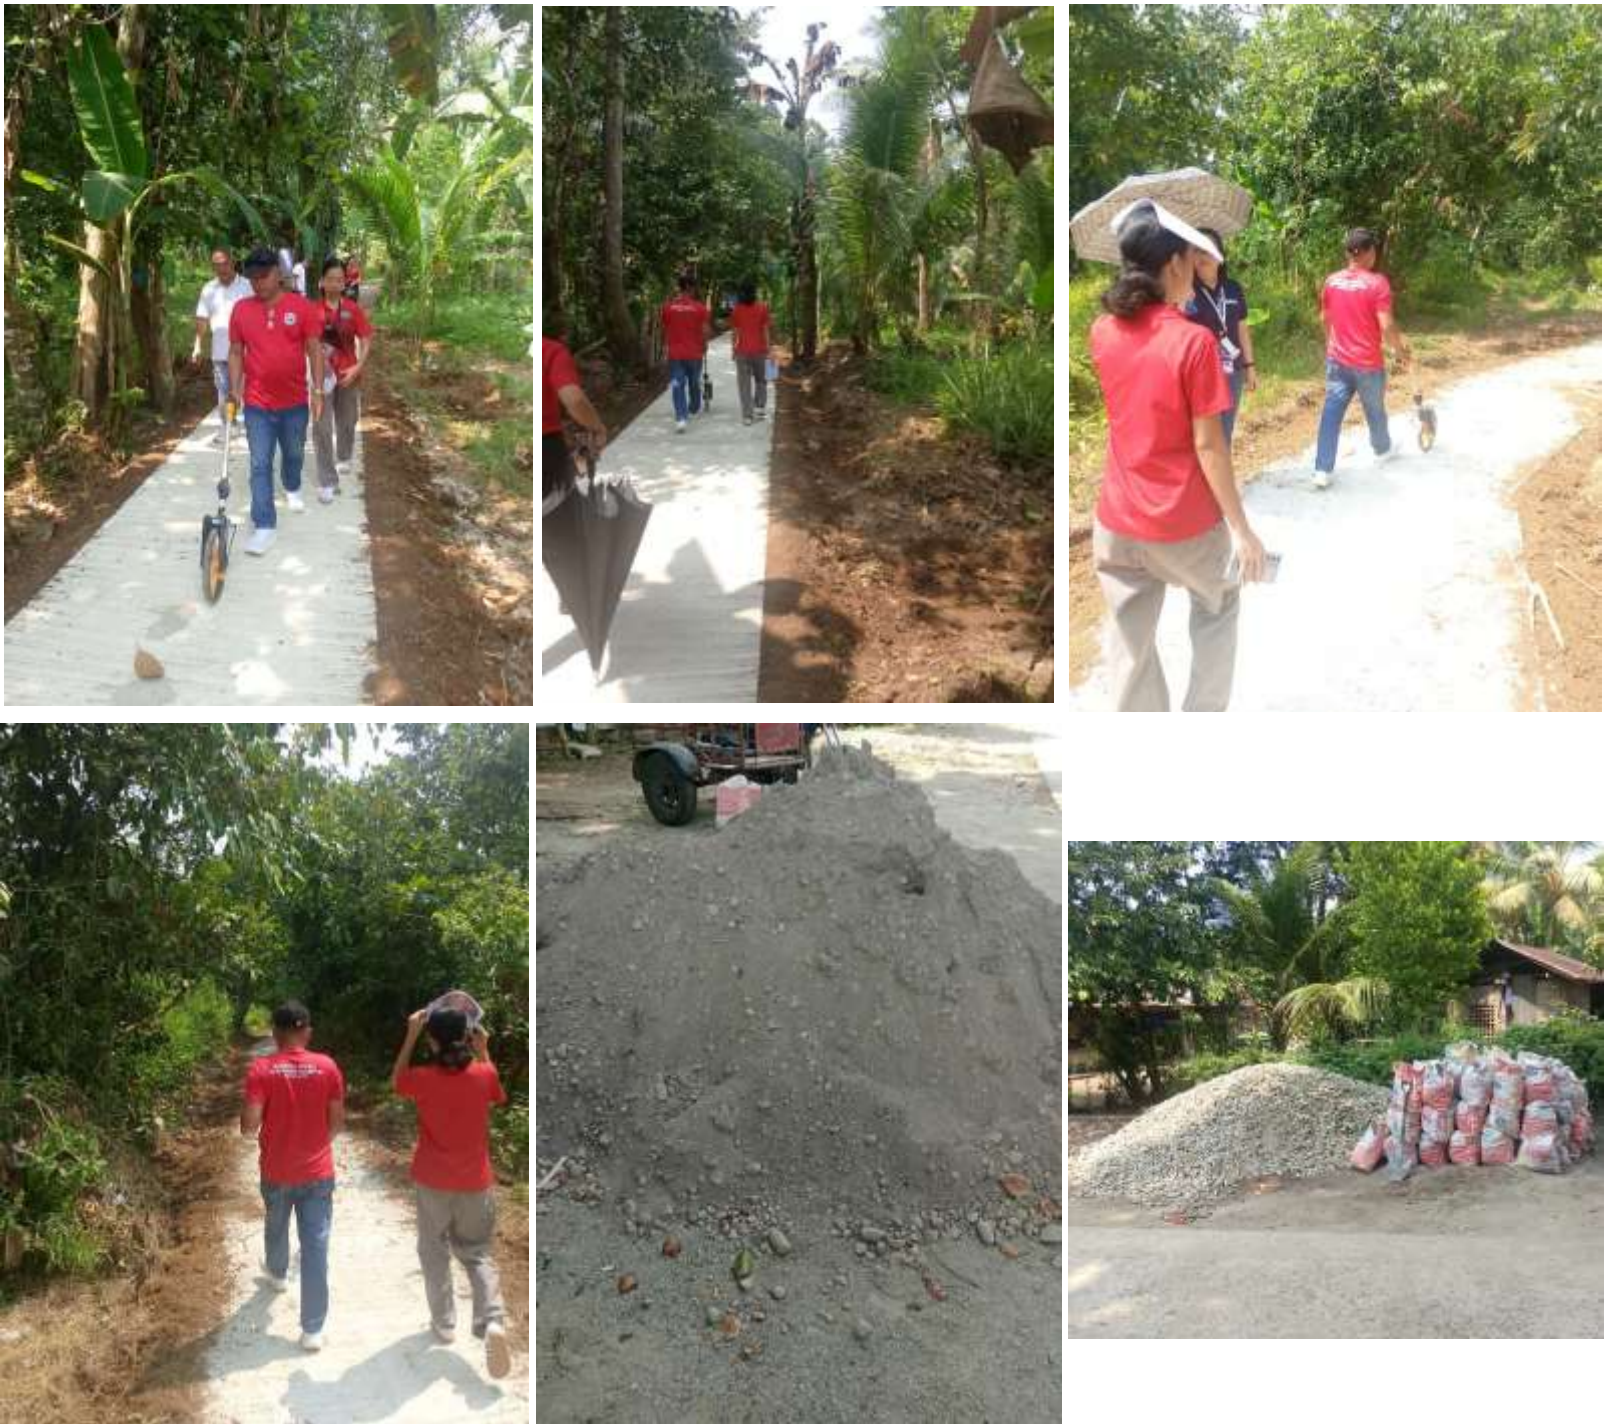
During the inspection of the Concreting of 170ln.m. along Sitio Marikot 1 to Marikot 2, Brgy. Bukid, Barugo, Leyte funded under the Department of the Interior and Local Government – Local Government Support Fund – Support to the Barangay Development Program (DILG LGSF-SBDP), the committee observed the presence of excess construction materials within the project vicinity, as well as scattered construction-related wastes in the surrounding area. The committee also conducted an actual measurement of the road project and verified that the length and width were accurately implemented based on the approved project specifications.
