Republic of the Philippines  
Province of Leyte  
**MUNICIPALITY OF HINDANG**  
oOo

## LOCAL PROJECT MONITORING COMMITTEE

### POST ACTIVITY REPORT RE ONSITE MONITORING AND INSPECTION

#### **FARM TO MARKET ROAD (BRGY. ANOLON- BRGY. HIMACUGO)**

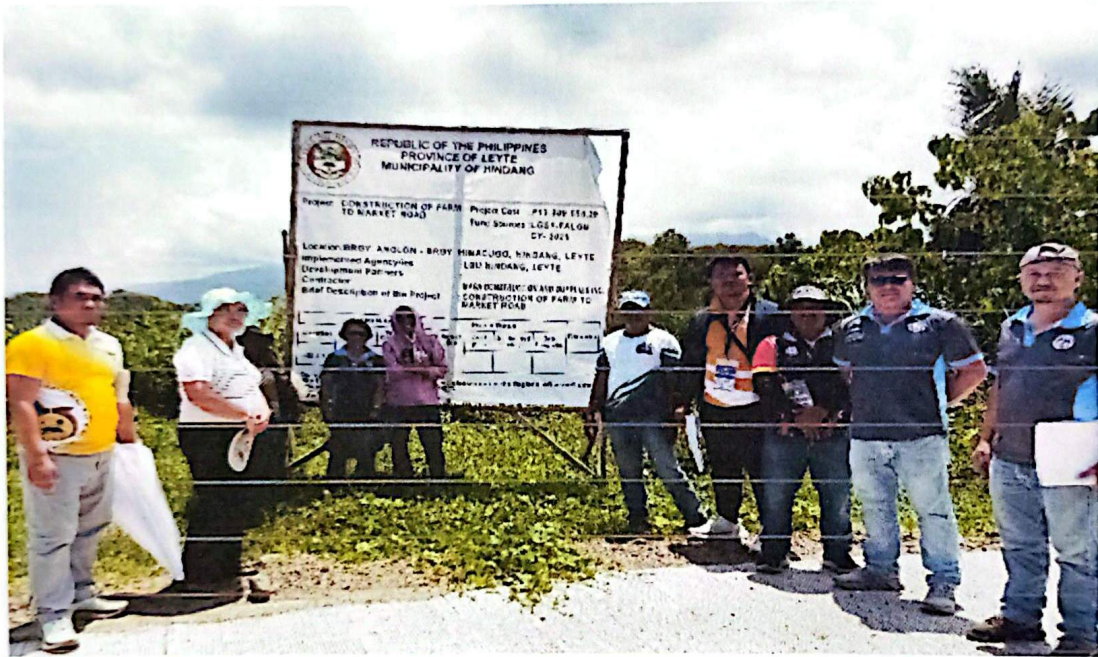
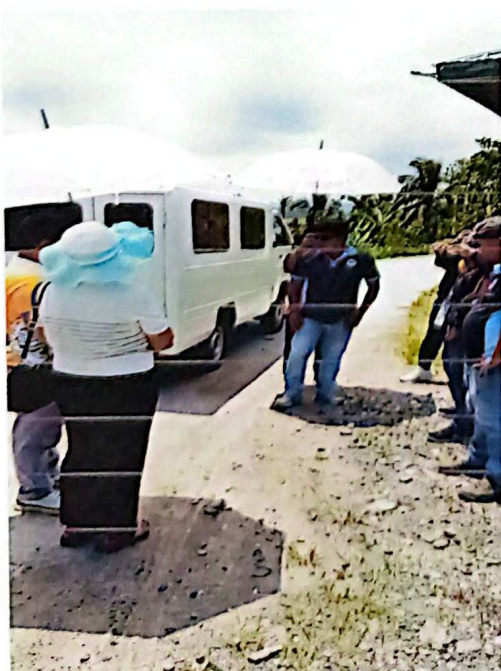
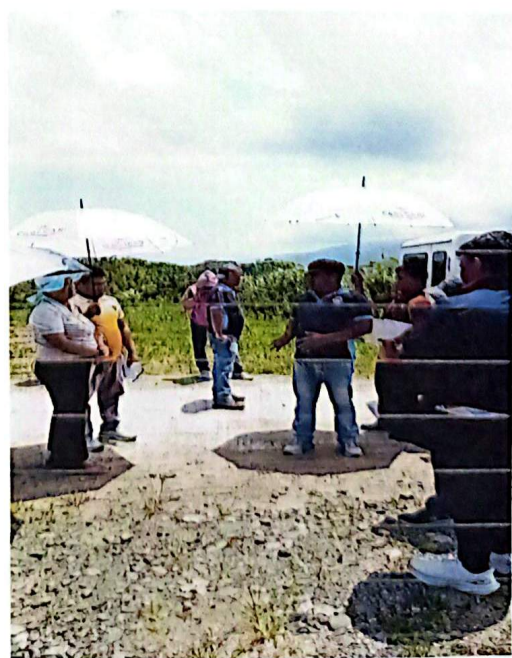
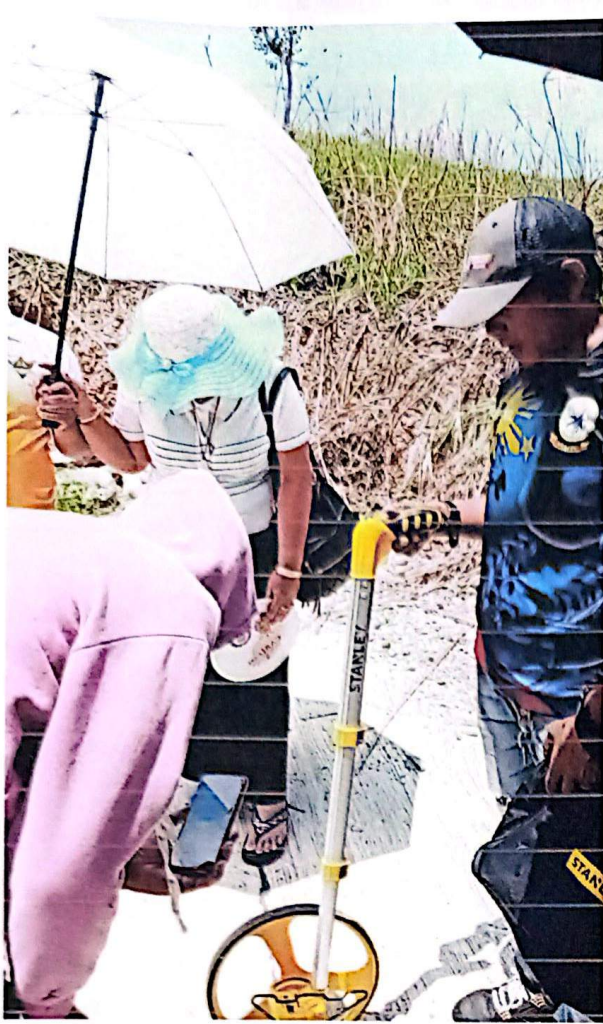
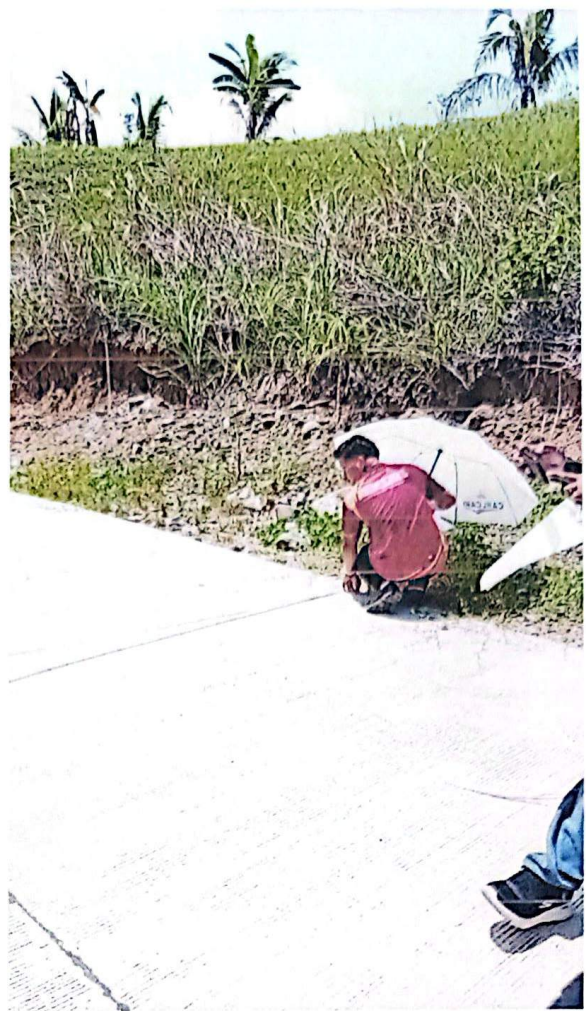
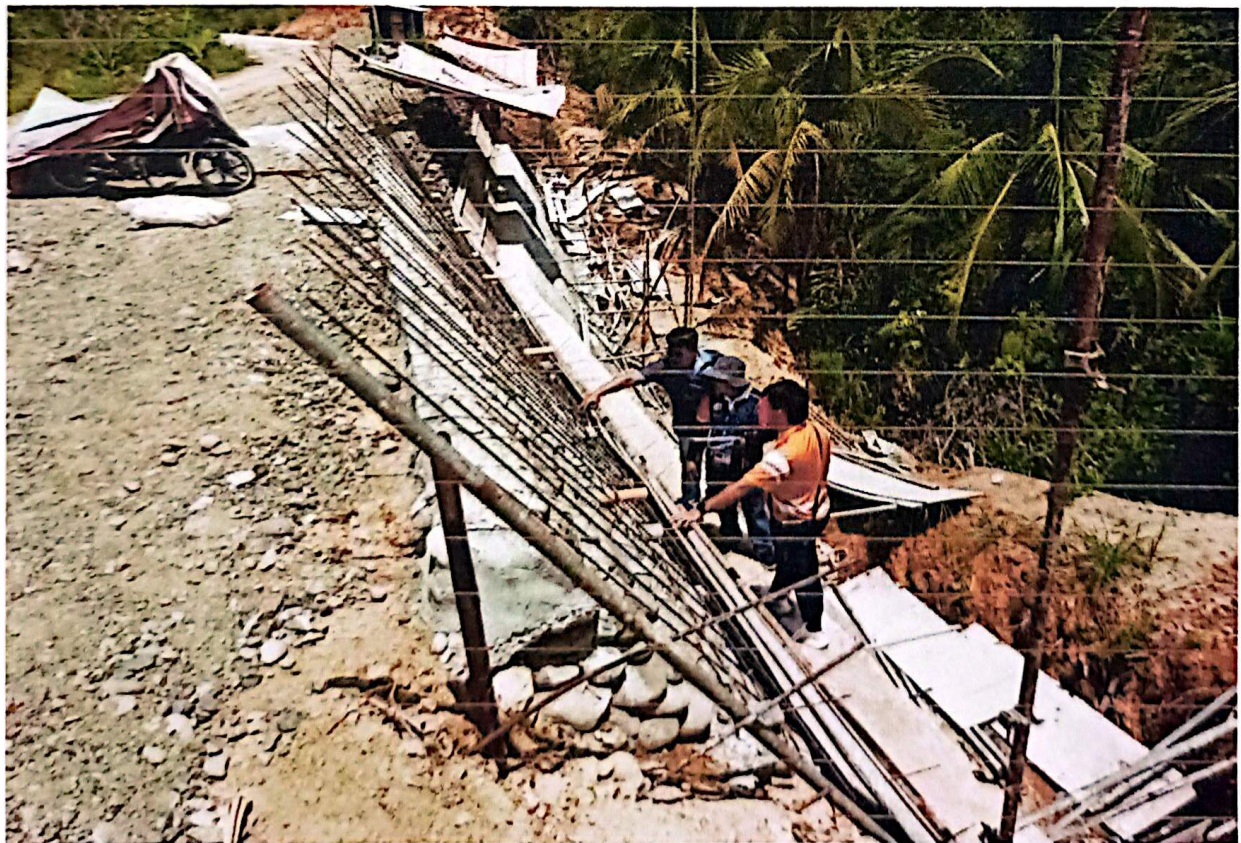
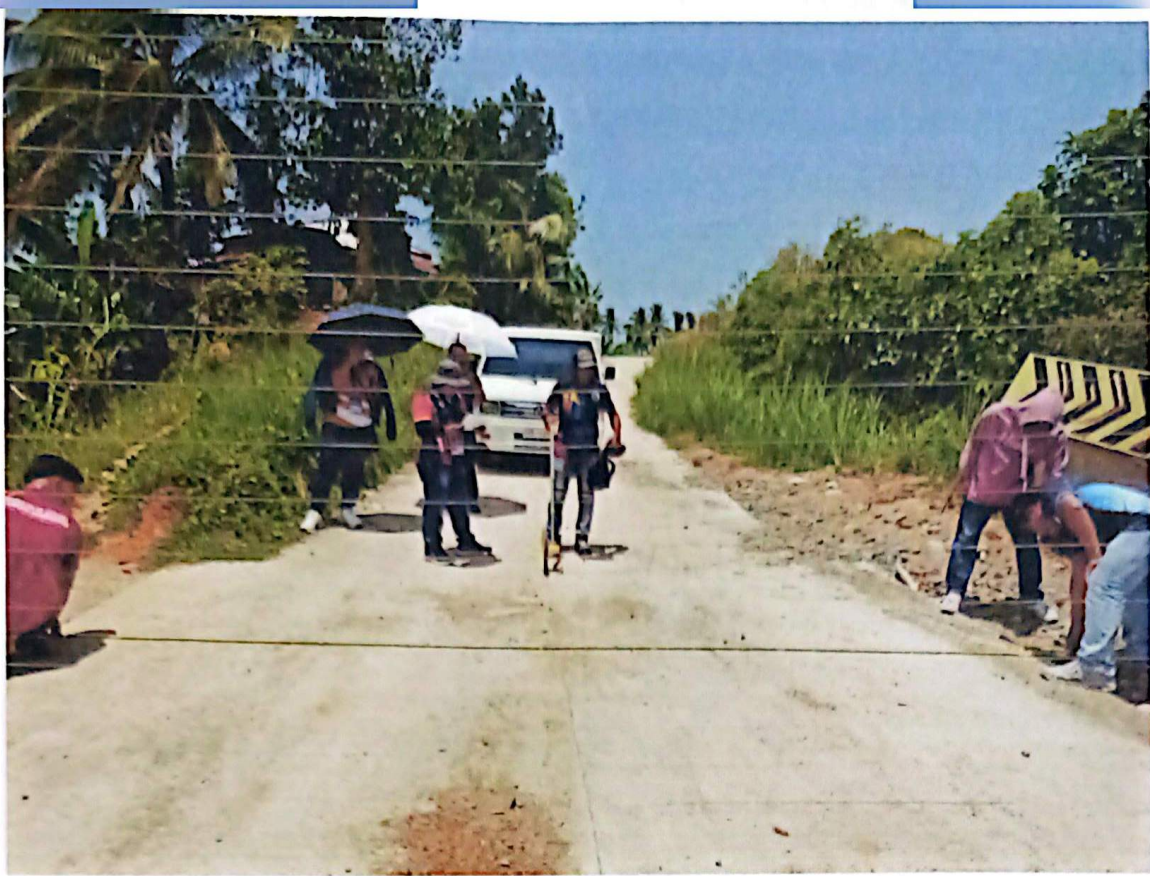
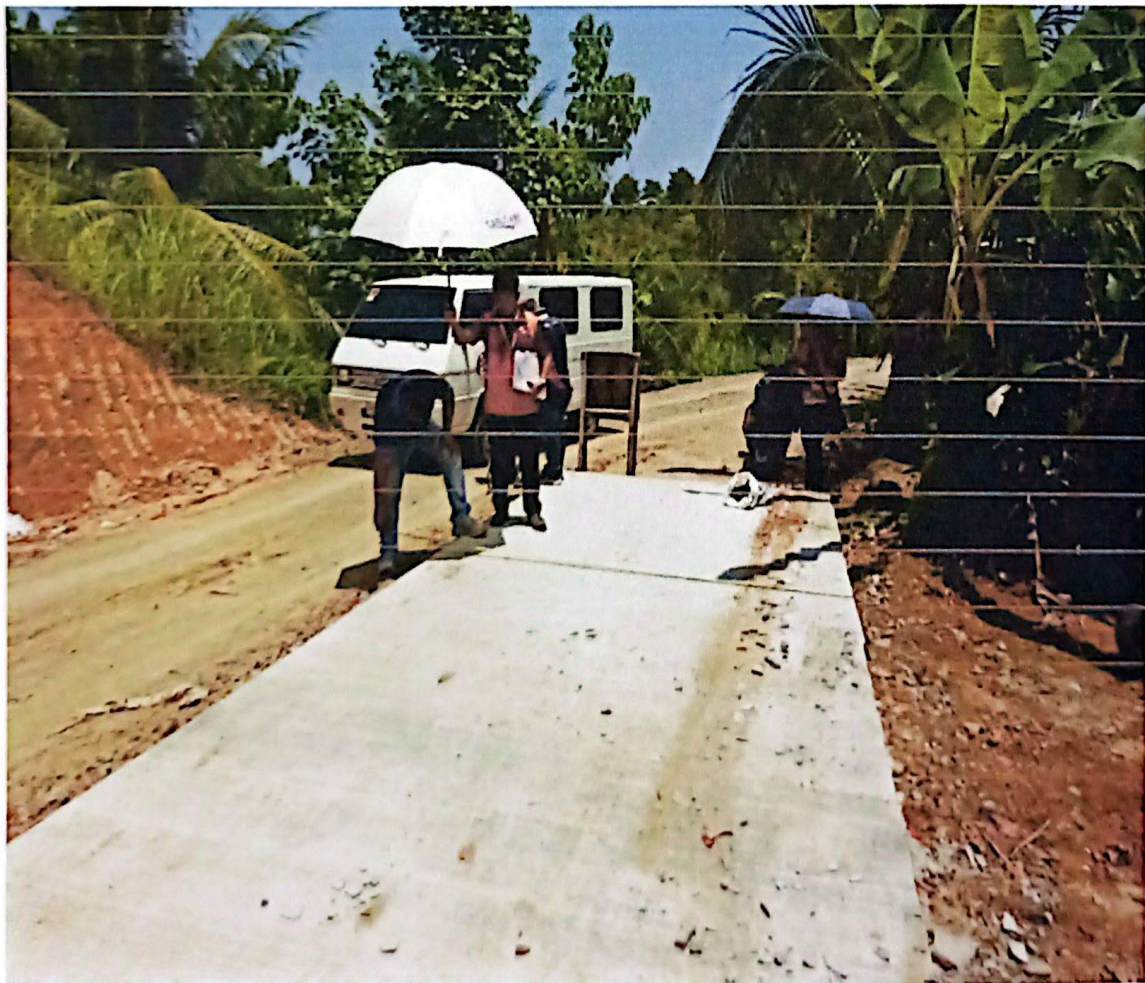
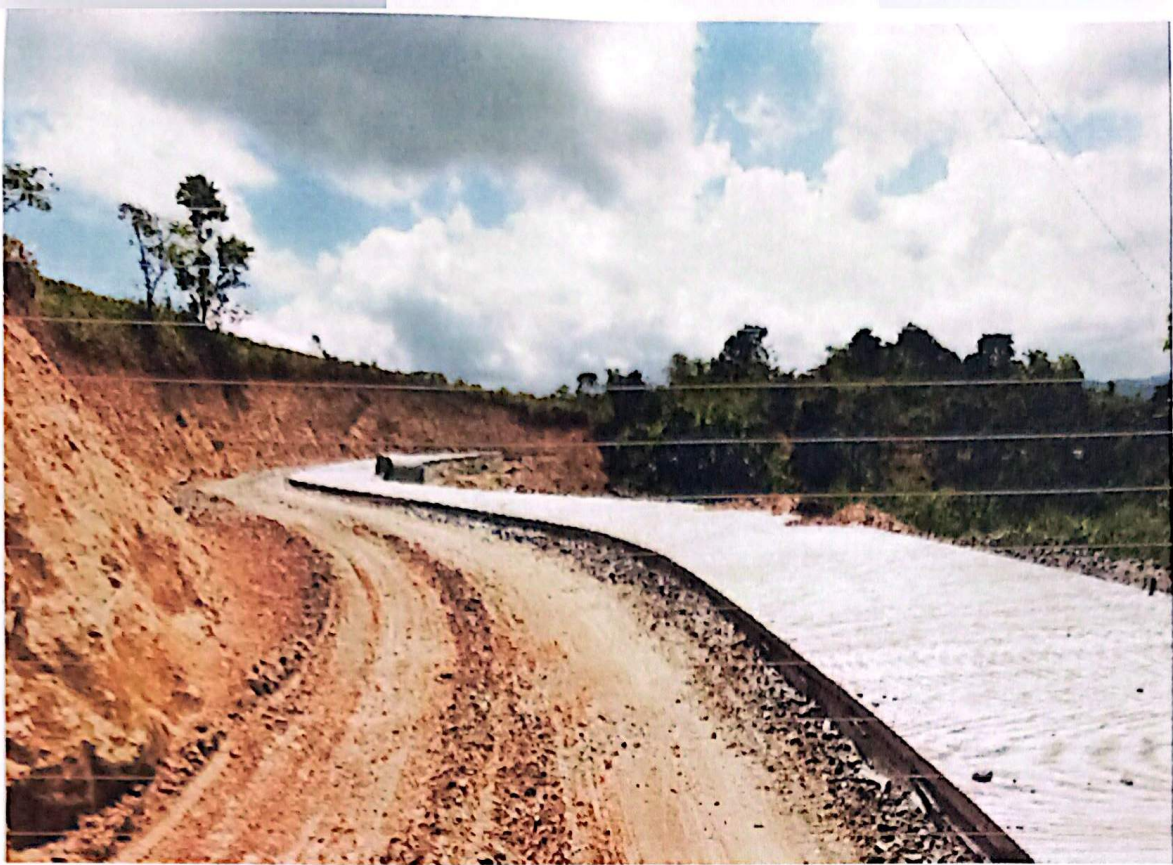
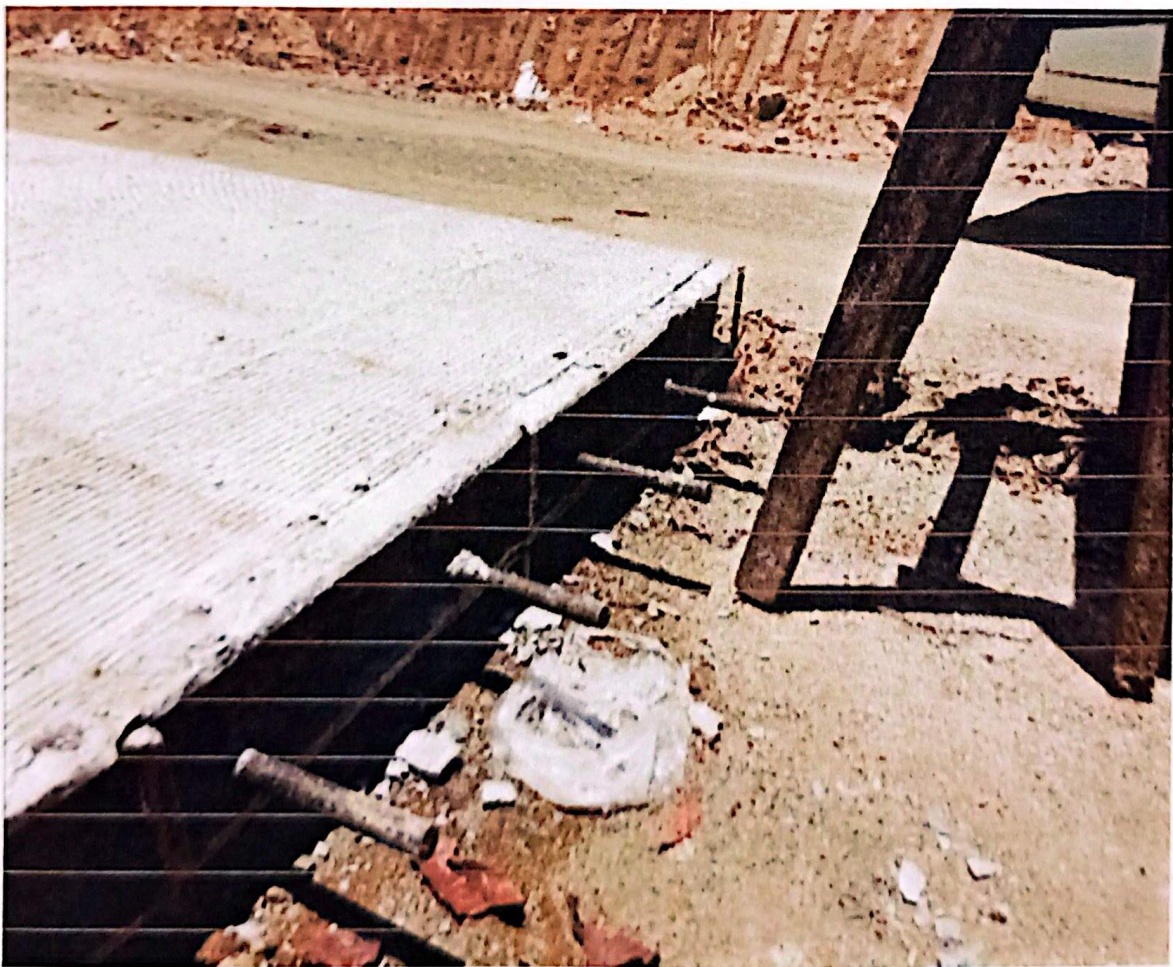
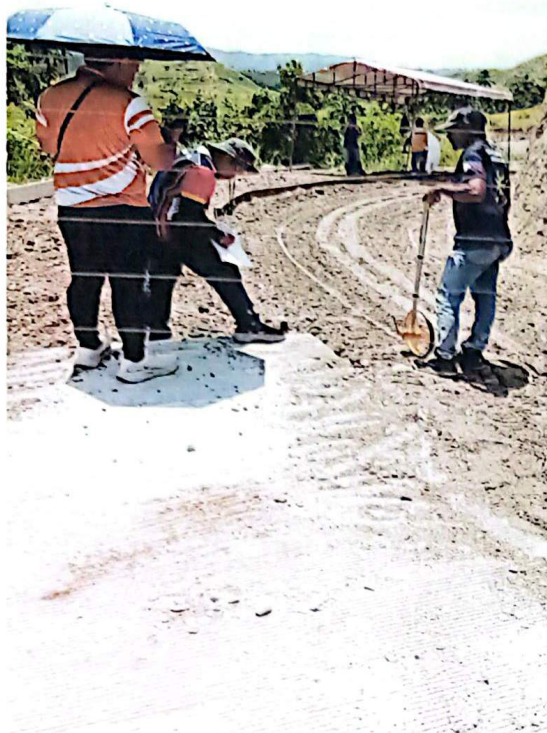
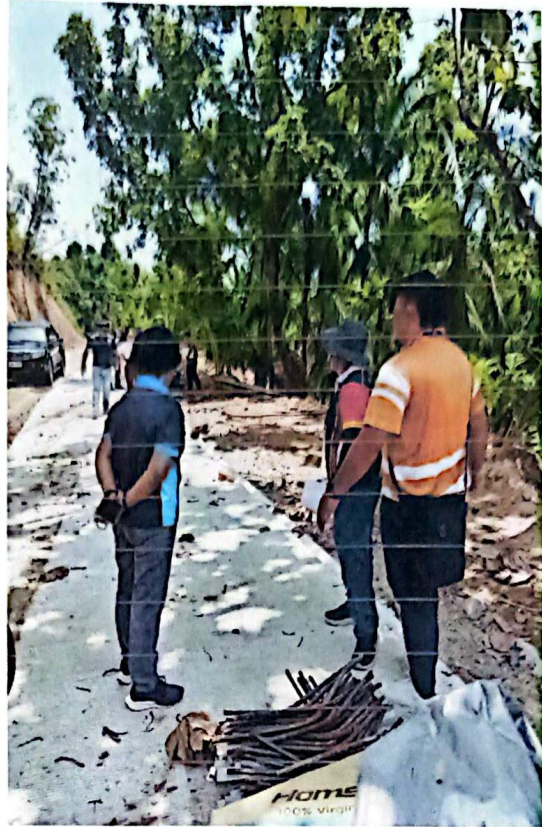
#### ACTUAL PHOTTO ON-SITE

During the assessment, Mr. Navia and Mr. Guya identified several critical deficiencies that require immediate corrective action. Most notably, they noted that the project is currently behind schedule, as the contract will expire on May 17, 2026, yet construction remains ongoing.

Additionally, the representatives observed mainline cracks on completed sections of the PCCP and a failure to apply the required asphalt sealant between Station 0+000 and Station 0+034.6.

To rectify these issues, the DILG representatives have recommended that the LGU immediately submit the necessary documentation, including the approved Work Suspension Order No. 2, Work Resumption Order No. 2, and the corresponding Time Extension No. 2.

Furthermore, they recommended that the contractor fast-track the implementation of the project by mobilizing additional manpower, ensuring the completed PCCP is kept properly hydrated to prevent further cracking, and applying sufficient asphalt sealant to all joint, specifically prioritizing the segment from Sta. 0+000 to Sta. 0+034.6—to prevent water infiltration and preserve the long-term integrity of the pavement.
