Republic of the Philippines  
Province of Leyte  
**MUNICIPALITY OF HINDANG**  
oOo

## LOCAL PROJECT MONITORING COMMITTEE

### POST ACTIVITY REPORT RE ONSITE MONITORING AND INSPECTION

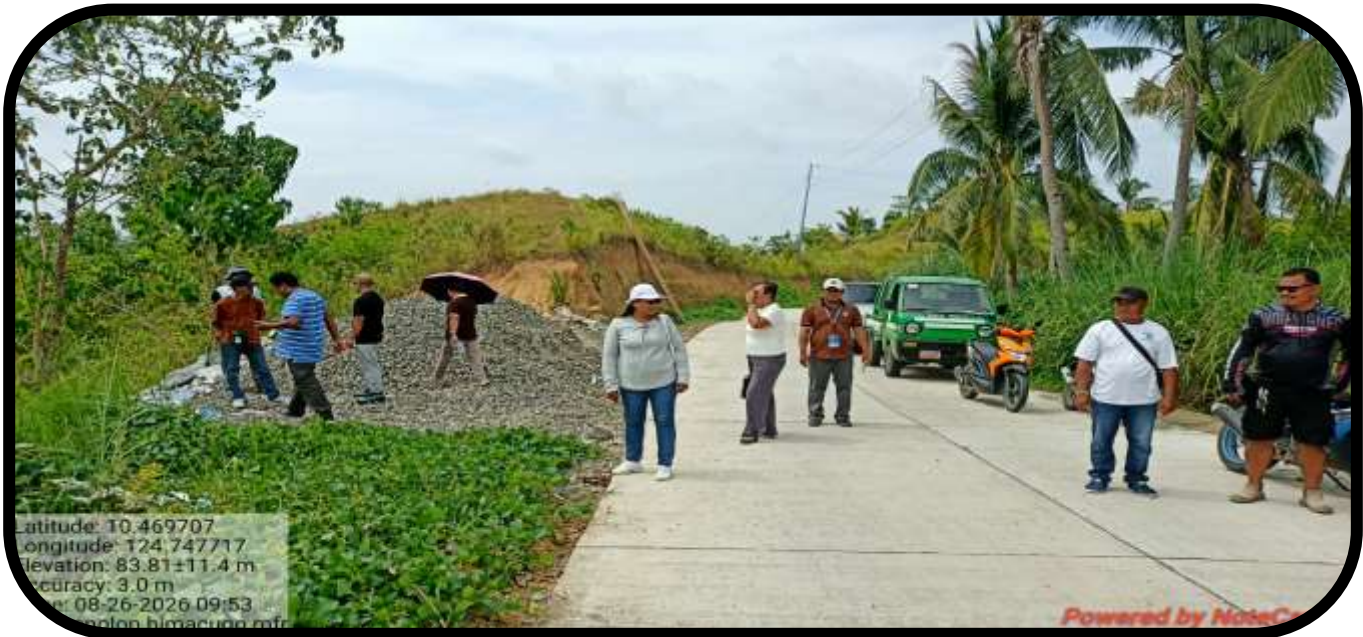
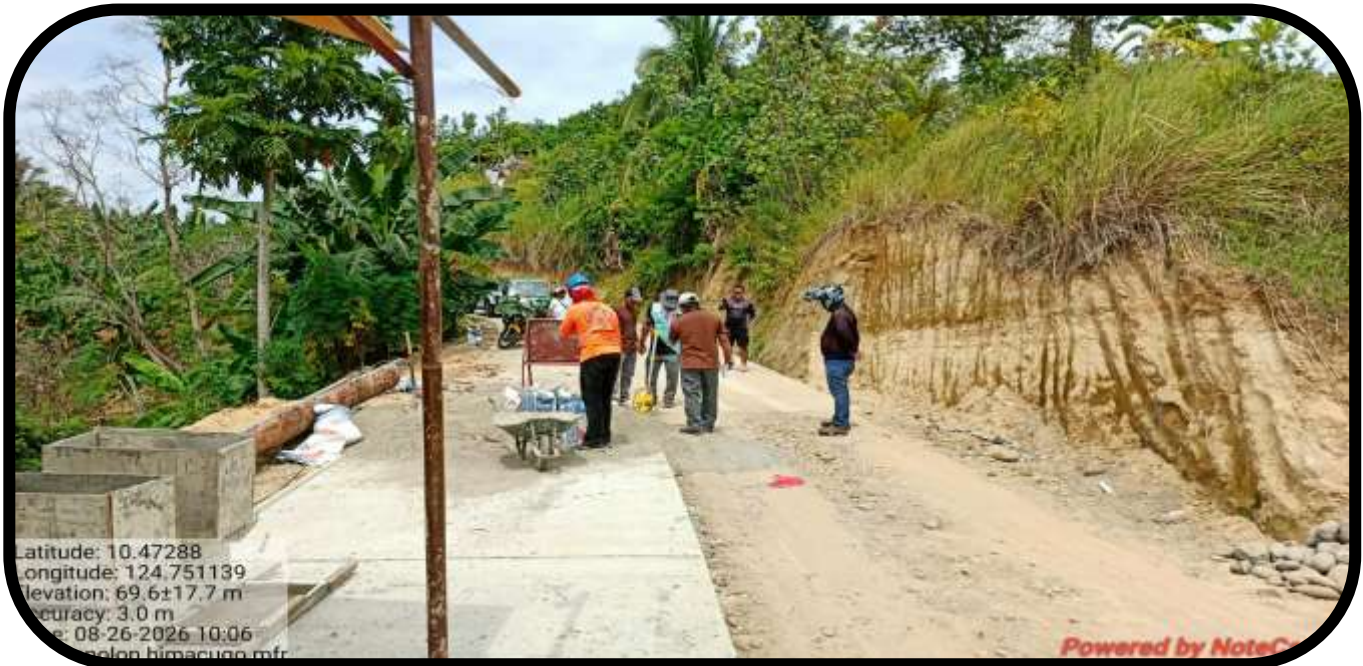
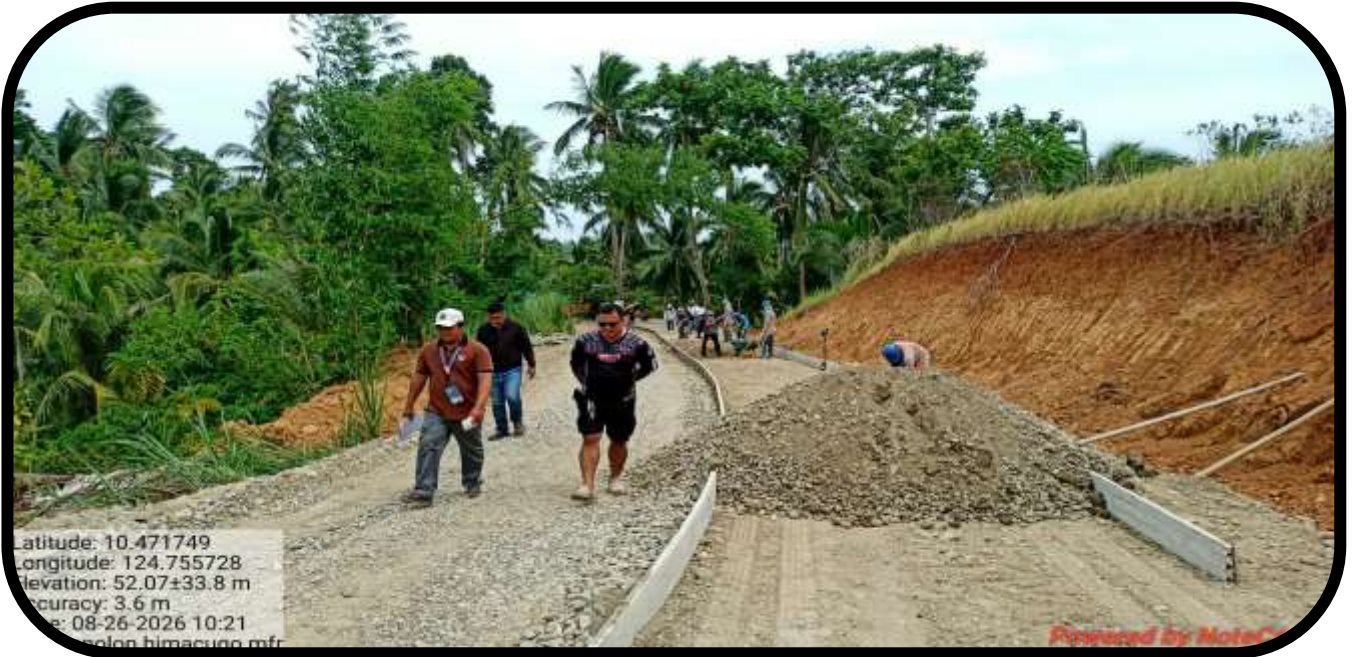
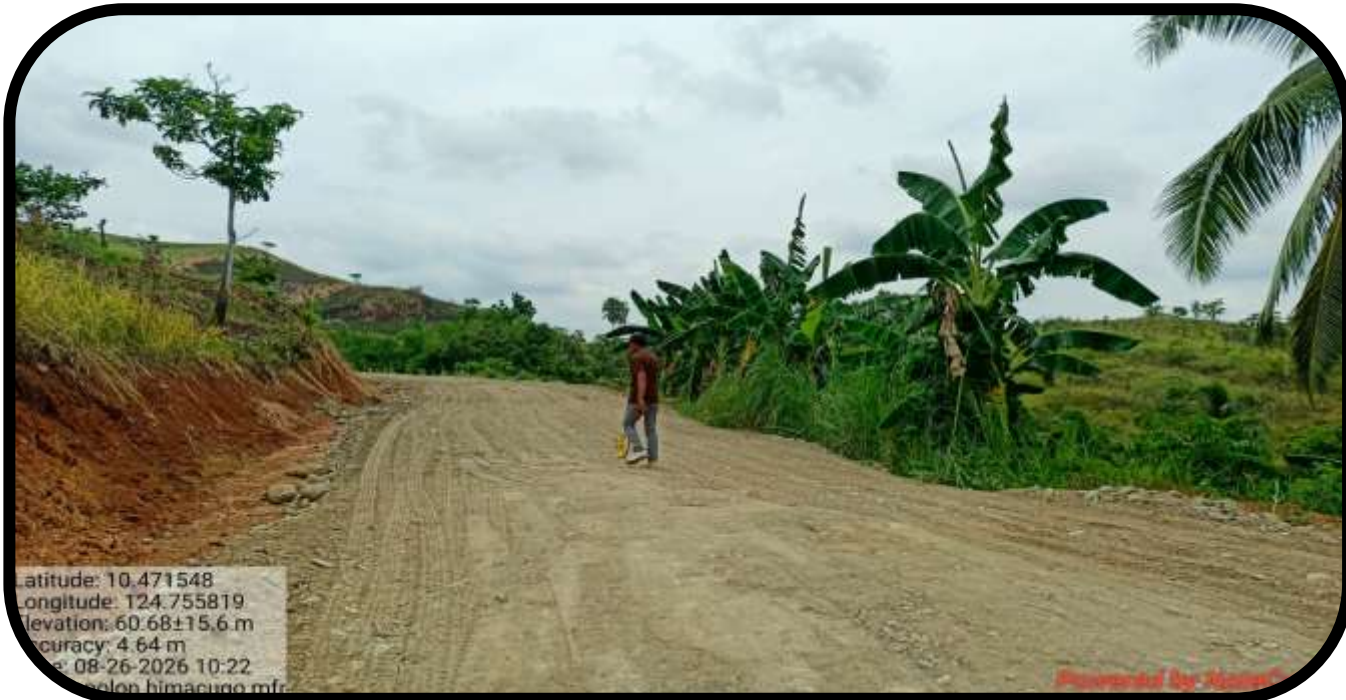
#### **FARM TO MARKET ROAD (BRGY. ANOLON- BRGY. HIMACUGO)**

1. The monitoring team noted substantial physical progress, specifically regarding the extended linear coverage of the roadway that has been successfully paved with Portland Cement Concrete Pavement (PCCP).
2. The monitoring team observed that specific portions of the roadway lanes remain uncompleted or are presently in active execution. These unfinished segments require closer supervision and accelerated construction timelines to eliminate bottlenecks and ensure seamless connectivity across the entire project alignment.
3. Certain portions of the roadway still lack Portland Cement Concrete Pavement (PCCP) surfacing, completely unpaved or presently undergoing active construction and earthwork execution.

Overall workmanship on the completed Portland Cement Concrete Pavement (PCCP) is satisfactory. However, the contractor was instructed to immediately deploy additional manpower and heavy equipment to accelerate ongoing works on unpaved sections and guarantee timely completion.

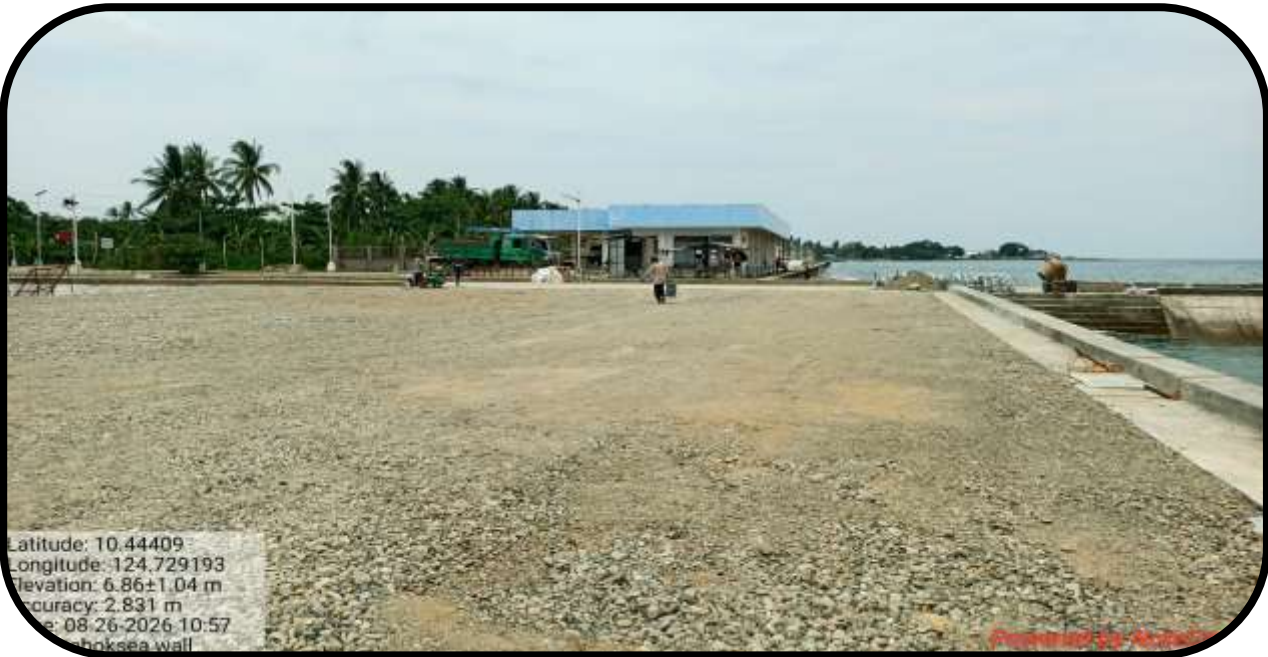
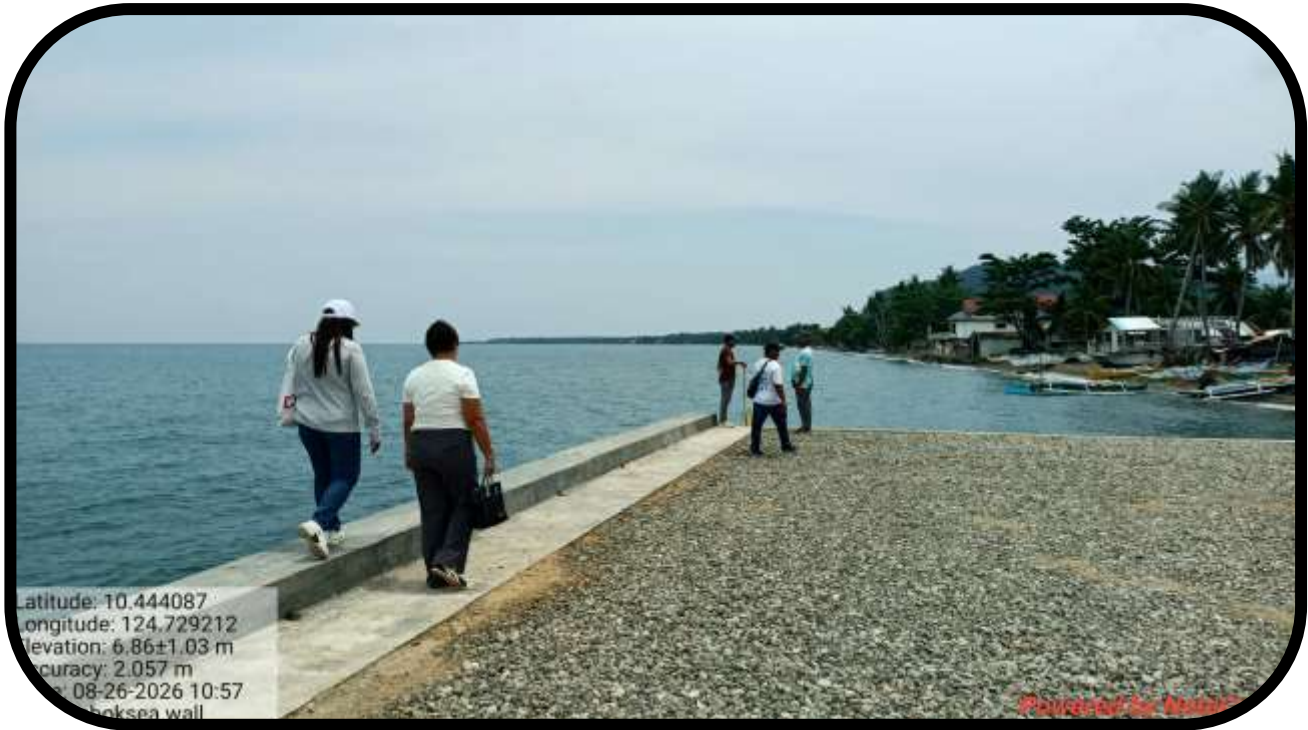
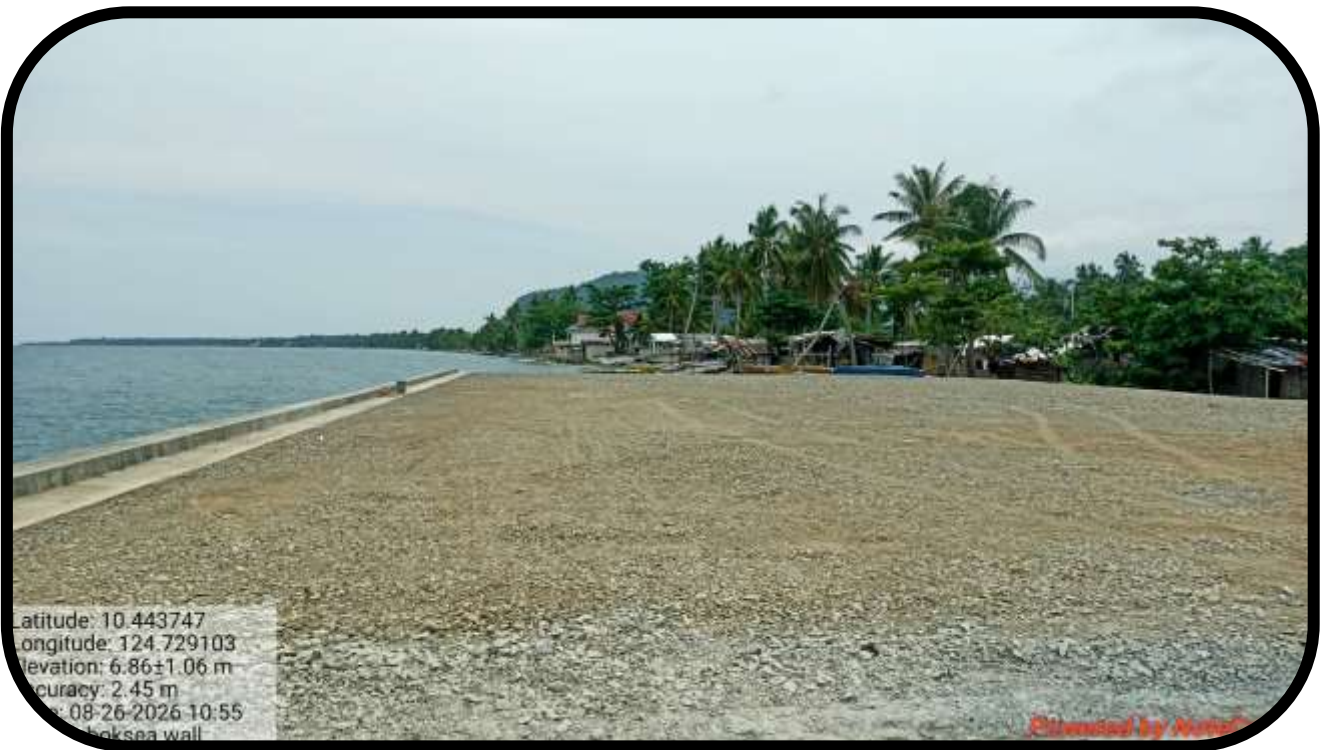
**CONSTRUCTION OF SEAWALL AND EMBANKMENT (MUNICIPAL PORT AREA)**

- 1. The concrete seawall structure has been fully constructed, showcasing uniform alignment, proper edge containment, and sound structural finishing along the port perimeter.
- 2. Extensive grading, leveling, and aggregate backfilling for the land reclamation and embankment platform behind the seawall have been successfully executed, significantly expanding the usable area within the municipal port zone.

Overall, the project is substantially completed in accordance with the intended physical scope as per observation.
